Manhole Inspection Summary

Manhole # S310O1027MH

Location Address: **CHARLES ST**

Cross Street: **COLDSPRING LA**

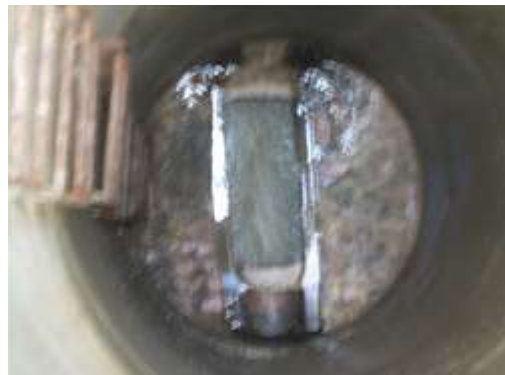
Top View

Corroded steps. Evidence of surcharge - Bench debris.

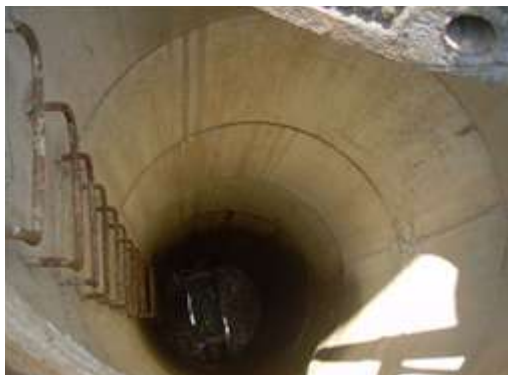
Defect

Infiltration: ☐ None ☒ **Joint** ☐ Cracks ☐ Mortar ☐ Roots ☐ Wall

Infiltration: ☐ None ☒ **Joint** ☐ Cracks ☐ Mortar ☐ Roots ☒ **Wall**

Adjustment, Corbel and Barrel infiltration.

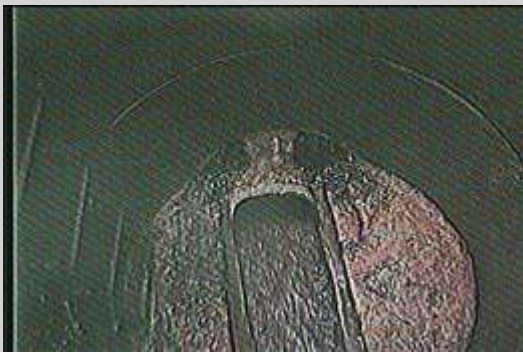
15 in. Circular Gravity Sewer Pipe Out @ 12 O'Clock

Pipe Material: **Unknown** ☒ Pipe Lined

Invert Depth: **24.10** (ft.) Flow Characteristics: **Fast**

Infiltration: **None** Pipe Seal Cond: **Unknown**

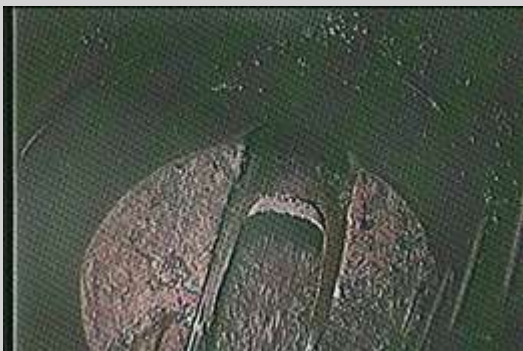
15 in. Circular Gravity Sewer Pipe In @ 6 O'Clock

Pipe Material: **Unknown** ☒ Pipe Lined

Invert Depth: **24.00** (ft.) Flow Characteristics: **Fast**

Infiltration: **None** Pipe Seal Cond: **Unknown**
